Additional Inspection Report

Wiley Elementary School
1602 S. Anderson Street
Urbana, IL 61801

2/4/2004

On February 4, 2004, EPA/AHERA accredited, IDPH licensed inspector Pete Altieri inspected Wiley Elementary School in Urbana, Illinois. The purpose of the inspection was to identify and sample suspect asbestos 12x12 floor tile mastic in the south hallway restrooms prior to planned removal. This inspection was performed to help stay in compliance with the AHERA rules and regulations governing asbestos in schools.

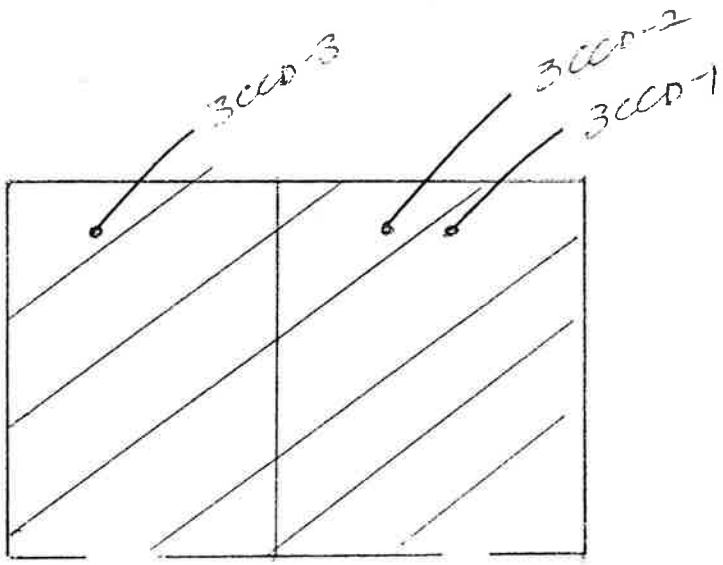
Wiley ELEM RESTROOMS

Sample Area ID: 3CCD
Job Name: Wiley Elementary School
Address: 1602 S. Anderson
Urbana, Illinois
Inspection Date: February 4, 2004
Inspector: Pete Altieri
Sample #: 3CCD-1,2,3

Description: 12x12 Floor Tile Mastic ///// Indicates Location of Material
