# Additional Inspection Report

Wiley Elementary School  
1602 S. Anderson Street  
Urbana, IL 61801

4/2/2008

On April 2, 2008, EPA/AHERA-accredited, IDPH-licensed inspector Gayle S. Price inspected Wiley Elementary School in Urbana, Illinois. The purpose of the inspection was to identify and sample suspect asbestos containing materials in the 1951 original building library room 32 prior to planned removal of a sink and cabinetry.

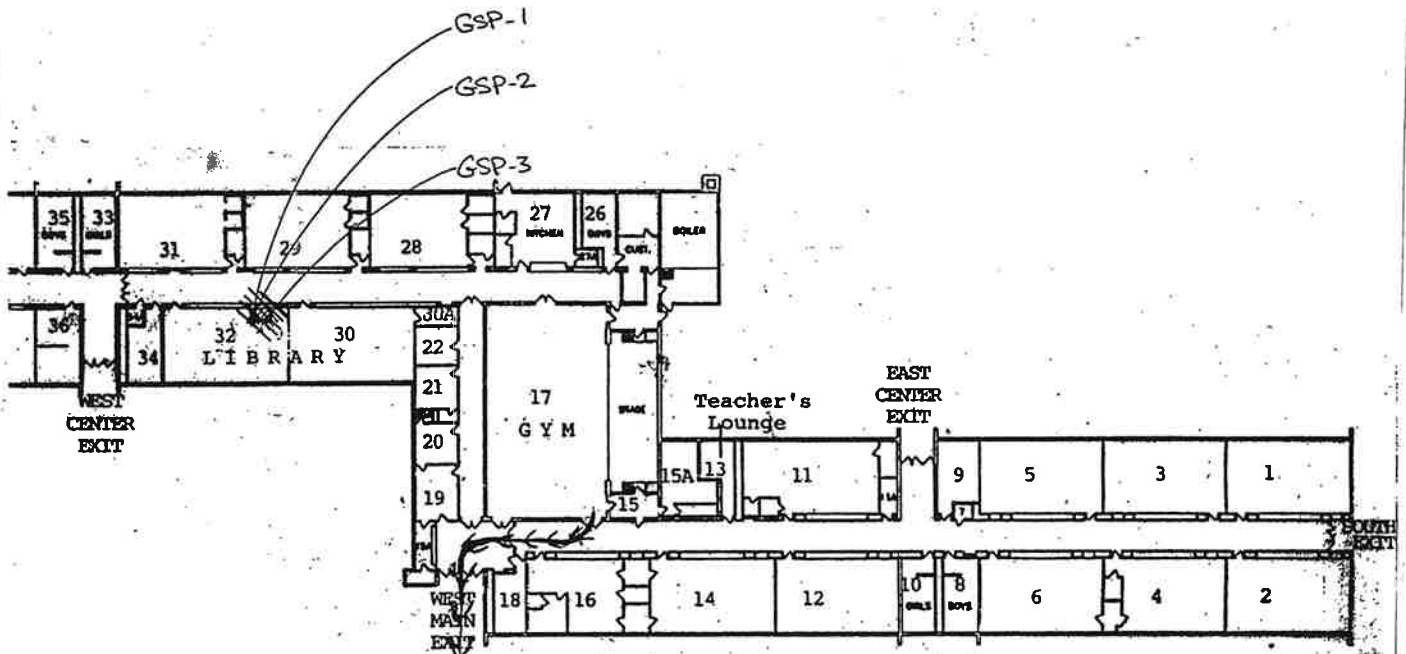
Description: Vinyl Backsplash Sheeting ||||| Indicates Location of Material

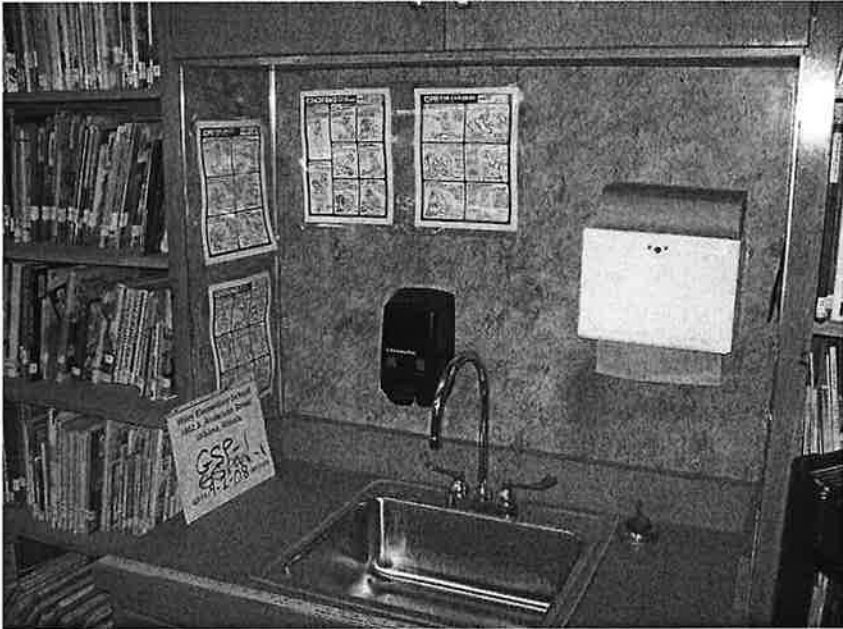
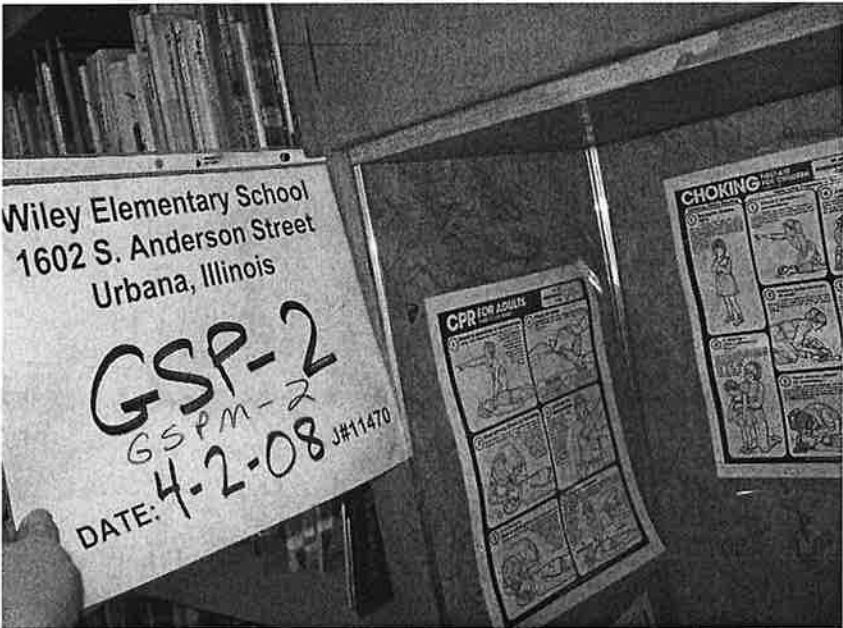
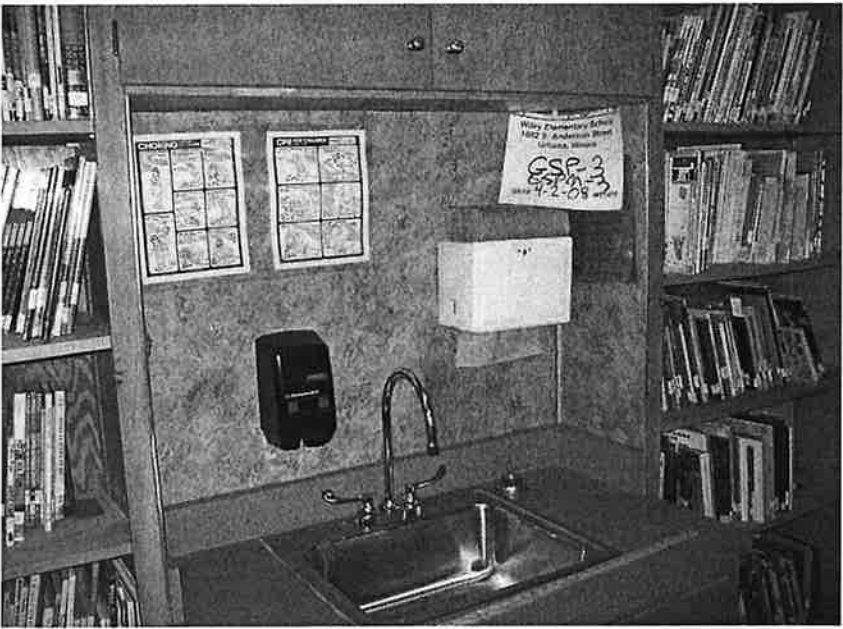
Sample Area ID: GSP  
Job Name: Wiley Elementary School  
Address: 1602 S. Anderson Street  
Urbana, IL 61801  
Inspection Date: April 2, 2008  
Inspector: Gayle S. Price  
Sample #: GSP -1,2,3

SCHOOL NAME:	Wiley Elementary School	INSPECTION DATE:	4/2/2008
CATEGORY:	Miscellaneous-NON-ACM	SAMPLE NUMBERS:	GSP-1,2,3
SAMPLE AREA ID:	GSP		
SAMPLE AREA NAME:	Vinyl Sheeting		
SAMPLE AREA DESCRIPTION:	Vinyl Backsplash Sheeting		
BUILDING:	1951 Original Building	AREA ESTIMATE:	15 sf
AREA LOCATION:	Library Room 32

ASBESTOS DETECTED:                      -Yes                      X -No

X -No Damage  
-Damage  
-Significant Damage

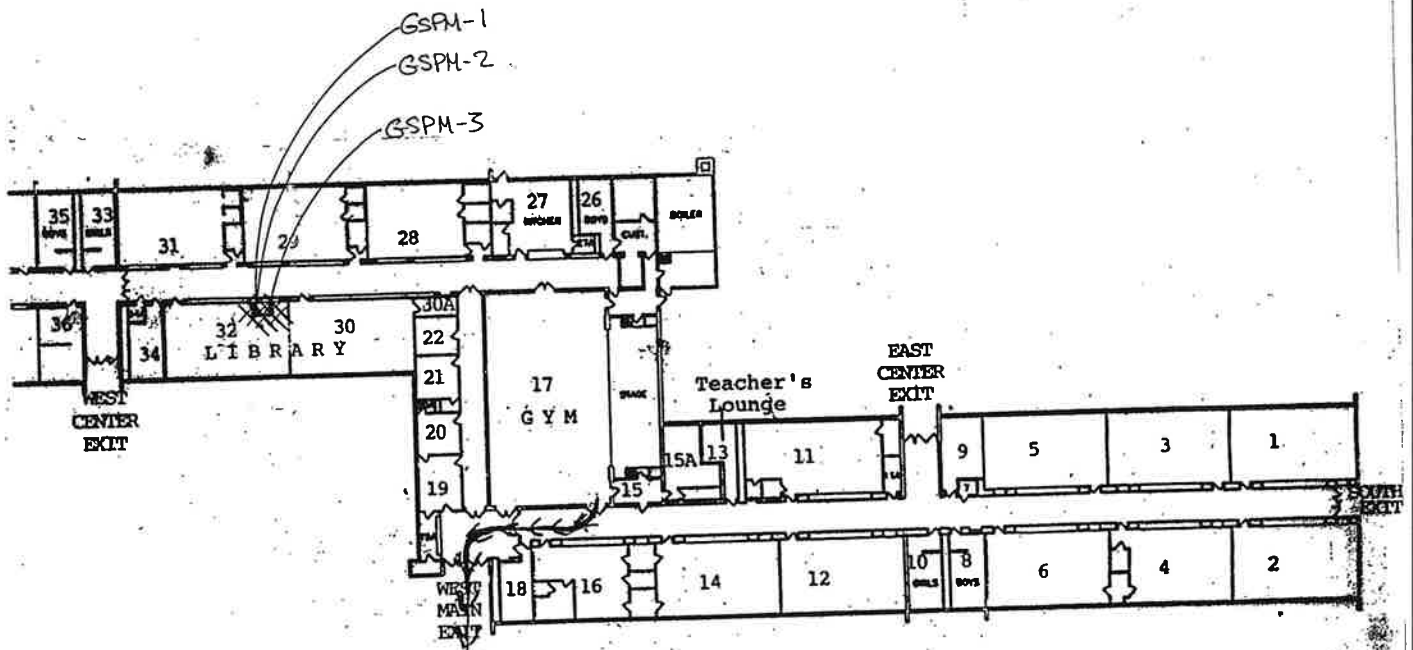
Description: Vinyl Backsplash Sheeting Mastic      \\\\\\\\\ Indicates Location of Material

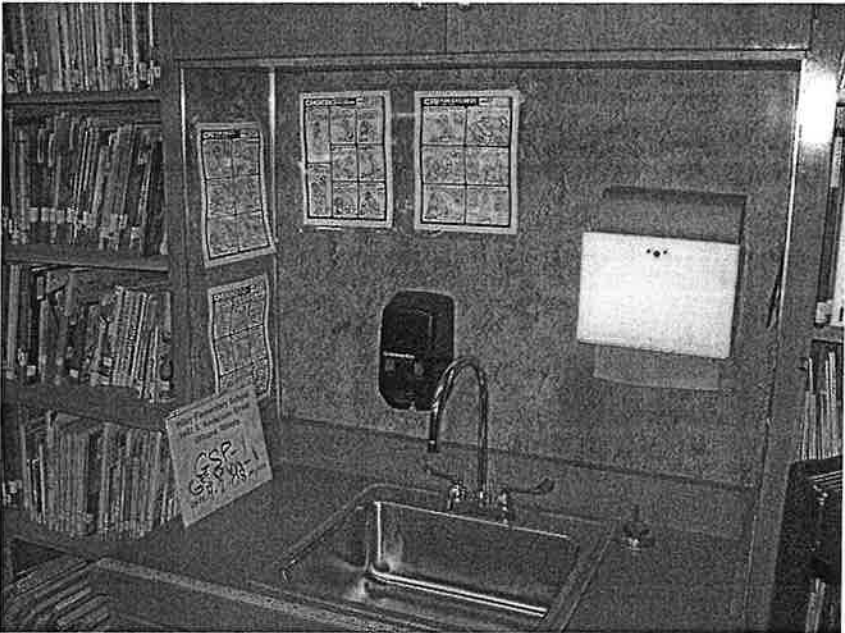
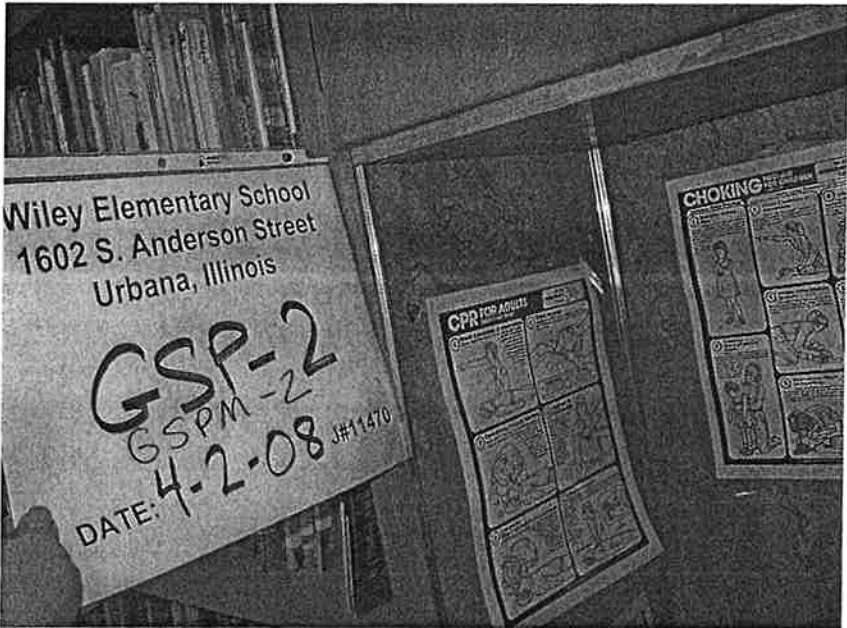
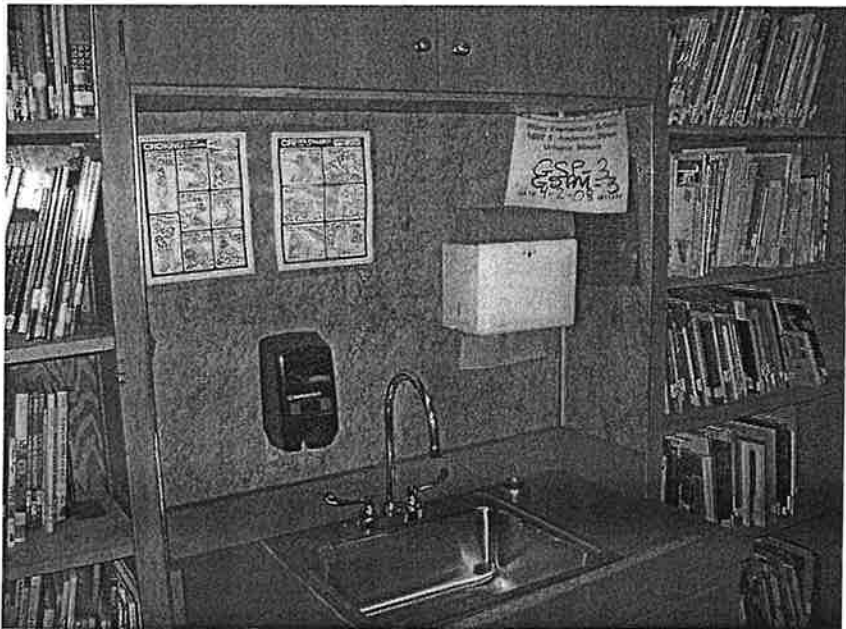
Sample Area ID: GSPM  
Job Name: Wiley Elementary School  
Address: 1602 S. Anderson Street  
Urbana, IL 61801  
Inspection Date: April 2, 2008  
Inspector: Gayle S. Price  
Sample #: GSPM -1,2,3

SCHOOL NAME:	Wiley Elementary School	INSPECTION DATE:	4/2/2008
CATEGORY:	Miscellaneous-NON-ACM	SAMPLE NUMBERS:	GSPM-1,2,3
SAMPLE AREA ID:	GSPM		
SAMPLE AREA NAME:	Mastic		
SAMPLE AREA DESCRIPTION:	Vinyl Backsplash Sheeting Mastic		
BUILDING:	1951 Original Building	AREA ESTIMATE:	15 sf
AREA LOCATION:	Library Room 32

ASBESTOS DETECTED:                      -Yes                      **X -No**

**X -No Damage**  
-Damage  
-Significant Damage
