Re: Asbestos Program
Wiley Elementary School
1602 S. Anderson Street, Urbana, IL 61801

Additional Inspection Report

July 18, 2018

21936

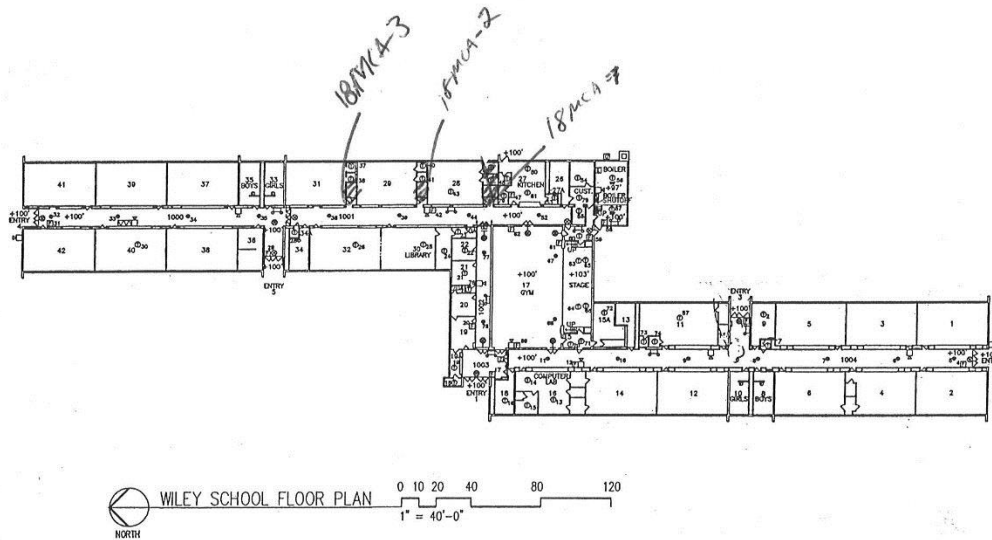
Sample Location Diagram

Sample Area ID & Number: **18MCA-1,2,3**

Area Description: **2x4 Pin Hole Fissured Lay-In Ceiling
Panels**

Material Location: **//////**

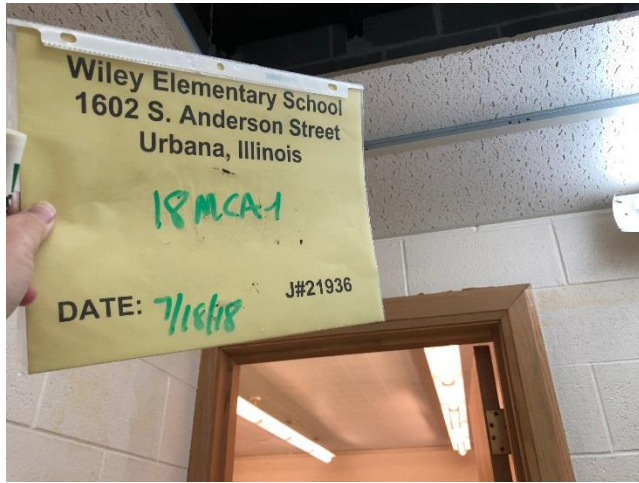
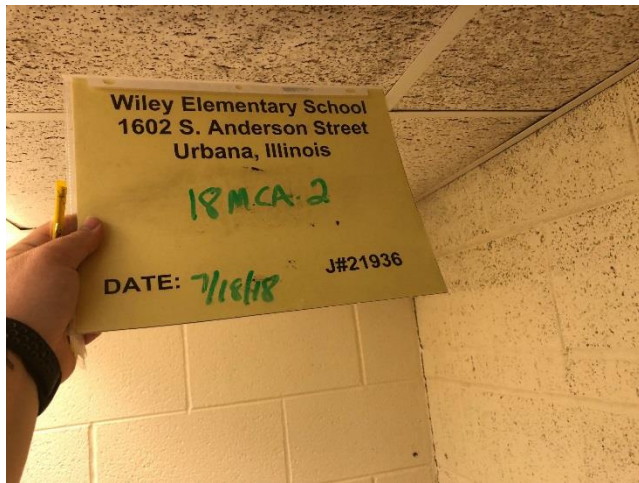
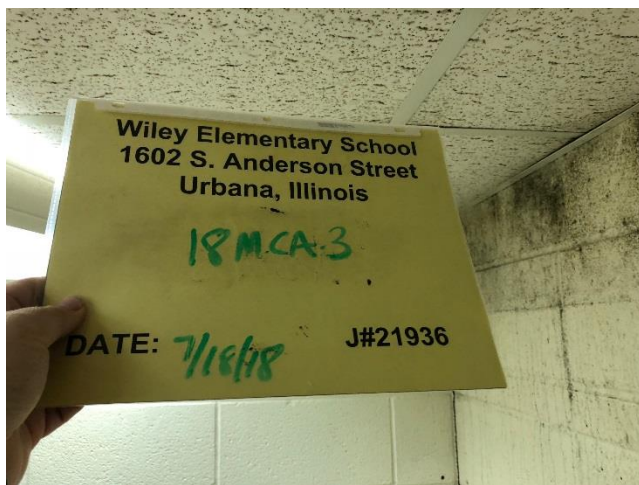
Sample Photos

ASBESTOS DETECTED: **No**

Area Description:	2x4 Pin Hole Fissured Lay-In Ceiling Panels
Area Location:	1951 Original Building Rooms 28, 29 & 31 Closets
