Re: Asbestos Program
Wiley Elementary School
1602 S. Anderson Street, Urbana, IL 61801

Additional Inspection Report

Wiley Elementary School
1602 S. Anderson Street
Urbana, IL 61801

May 9, 2019

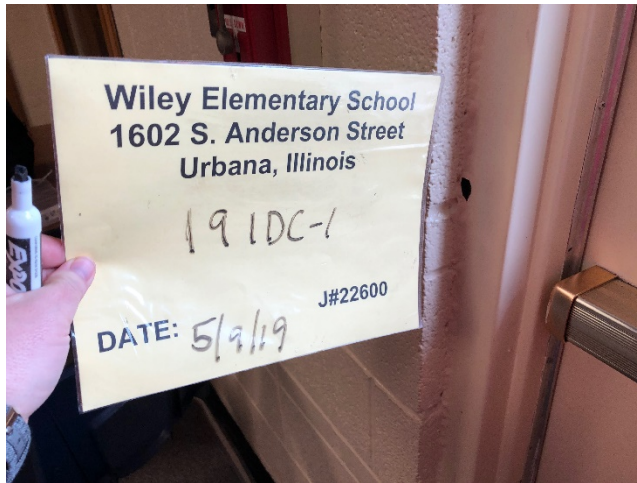
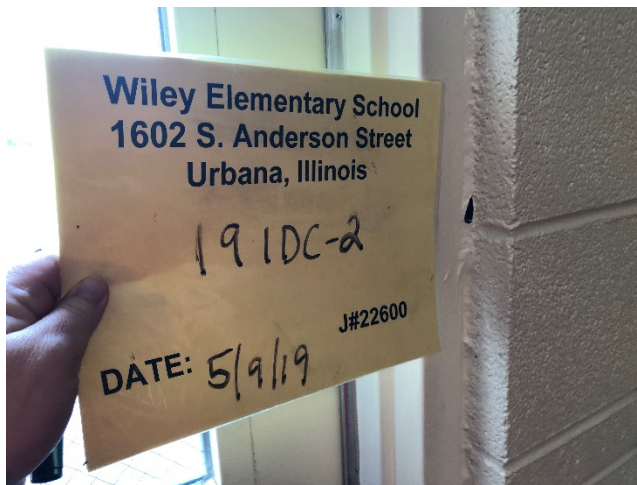
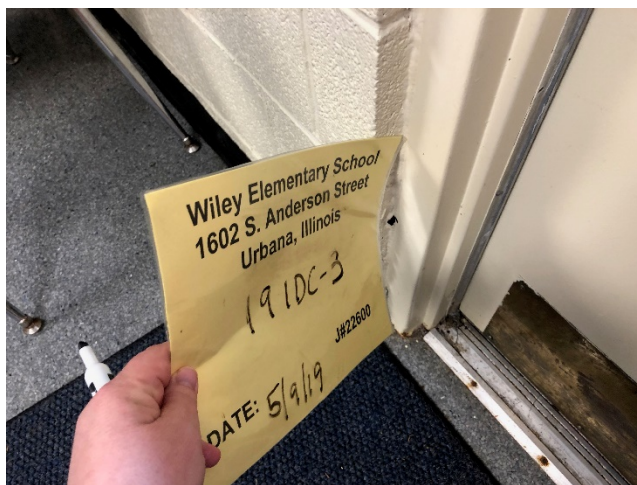
CATEGORY: **Miscellaneous-ACM**
 SAMPLE AREA ID: **19IDC** SAMPLE NUMBERS: **19IDC-1,2,3**
 AREA NAME: **Caulk** AREA ESTIMATE: **28 lf**
 AREA DESCRIPTION: **Interior Door Caulk**
 AREA LOCATION: **1951 Orig Bldg Main Entrance**

ASBESTOS DETECTED: Yes FRIABLE: No TYPE OF ASBESTOS: Chrysotile % OF CONTENTS: 2.31% COMMENTS: The material was analyzed by Polarized Light Microscopy (PLM) & Transmission Electron Microscopy (TEM).	CATEGORIZATION OF ACM <i>(for renovation purposes)</i> ACM CATEGORY: Non-Friable Category I REGULATED ACM: No
---	---

No Damage

Area Description:	Interior Door Caulk
Area Location:	1951 Orig Bldg Main Entrance

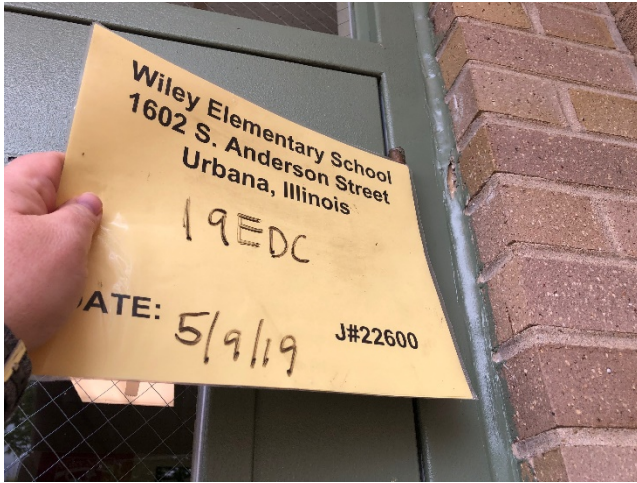
CATEGORY: **Miscellaneous-NON-ACM**
SAMPLE AREA ID: **19EDC** SAMPLE NUMBERS: **19EDC-1,2,3**
AREA NAME: **Caulk** AREA ESTIMATE: **28 lf**
AREA DESCRIPTION: **Exterior Door Caulk**
AREA LOCATION: **1951 Orig Bldg Main Entrance**

ASBESTOS DETECTED: **No**

Area Description:	Exterior Door Caulk
Area Location:	1951 Orig Bldg Main Entrance

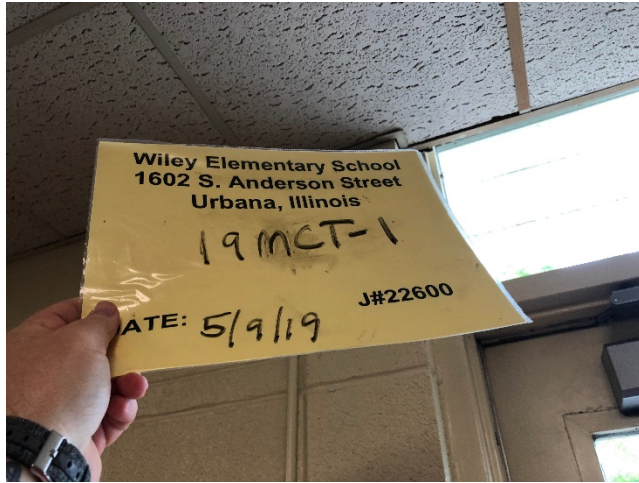
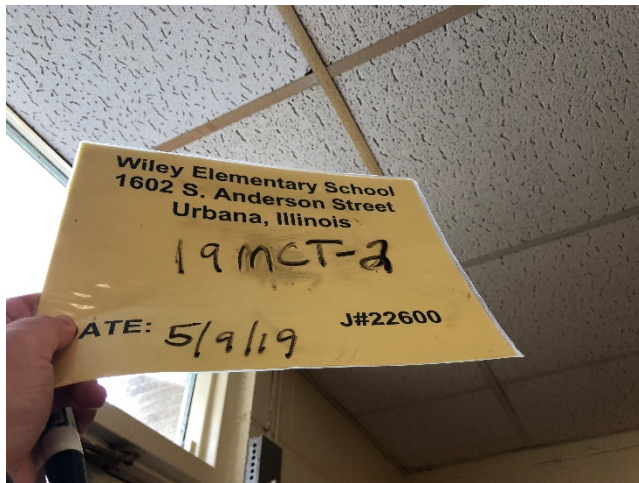
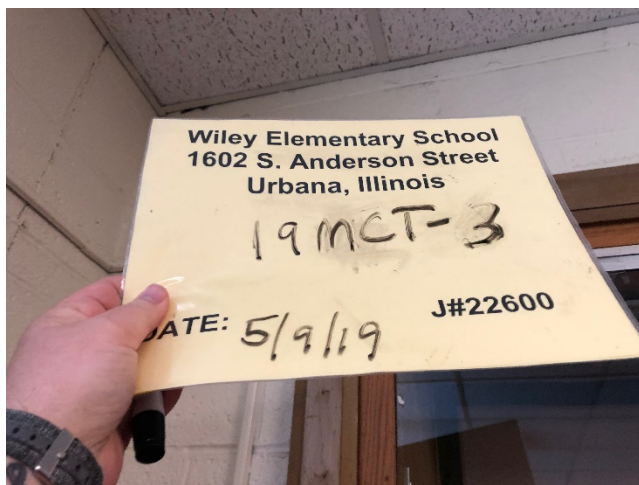
CATEGORY: **Miscellaneous-NON-ACM**
SAMPLE AREA ID: **19MCT** SAMPLE NUMBERS: **19MCT-1,2,3**
AREA NAME: **Ceiling Panels** AREA ESTIMATE: **416 sf**
AREA DESCRIPTION: **2x2 Lay-In Ceiling Panels**
AREA LOCATION: **1951 Orig Bldg Main Entrance**

ASBESTOS DETECTED: **No**

Area Description:	2x2 Lay-In Ceiling Panels
Area Location:	1951 Orig Bldg Main Entrance

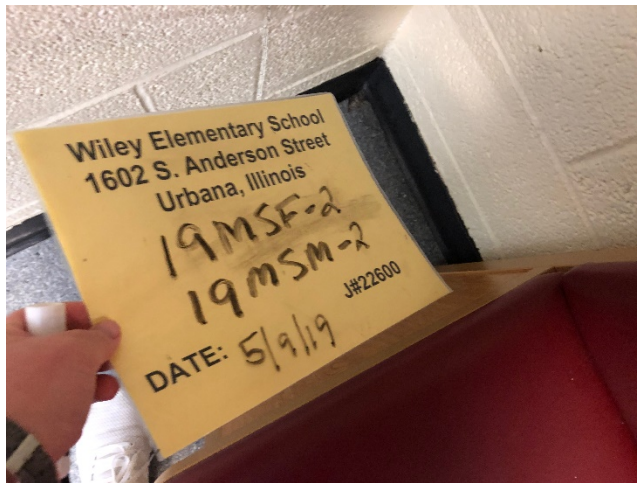
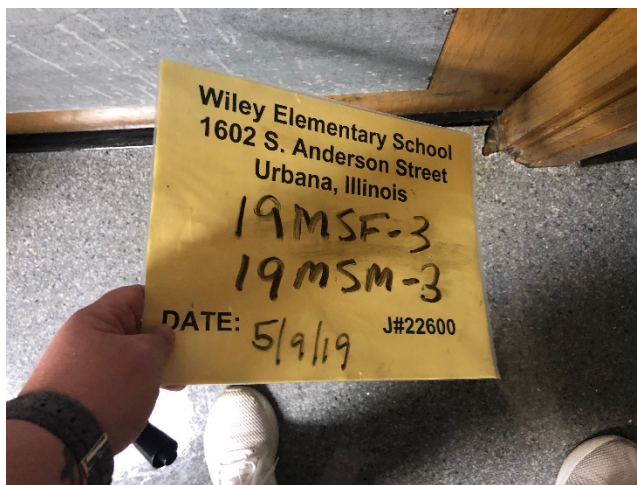
CATEGORY: **Miscellaneous-NON-ACM**
SAMPLE AREA ID: **19MSF** SAMPLE NUMBERS: **19MSF-1,2,3**
AREA NAME: **Sheet Flooring** AREA ESTIMATE: **416 sf**
AREA DESCRIPTION: **Blue Sheet Flooring**
AREA LOCATION: **1951 Orig Bldg Main Entrance**

ASBESTOS DETECTED: **No**

Area Description:	Blue Sheet Flooring
Area Location:	1951 Orig Bldg Main Entrance

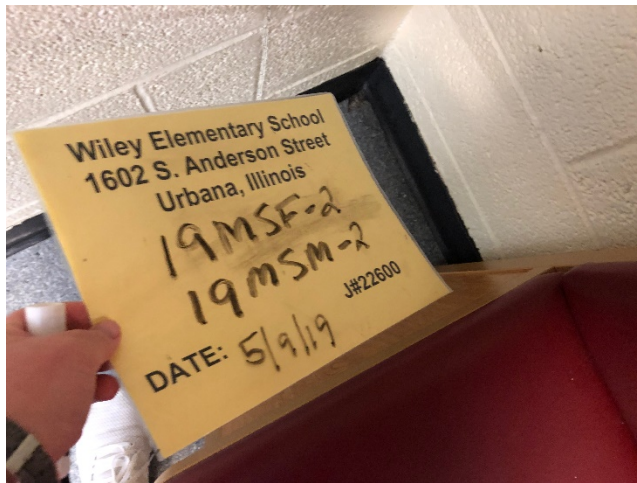
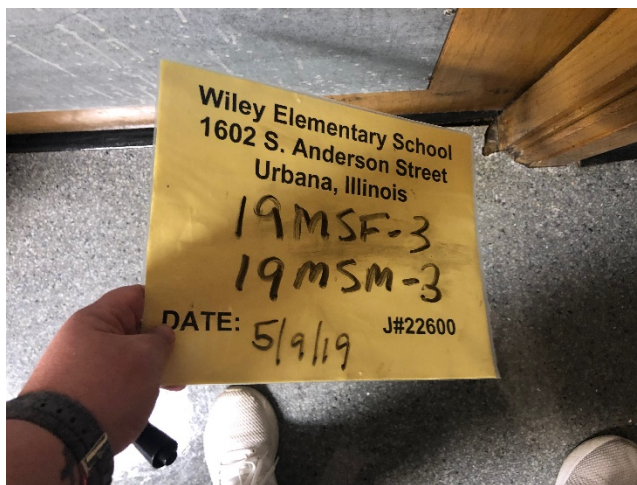
CATEGORY: **Miscellaneous-NON-ACM**
SAMPLE AREA ID: **19MSM** SAMPLE NUMBERS: **19MSM-1,2,3**
AREA NAME: **Mastic** AREA ESTIMATE: **416 sf**
AREA DESCRIPTION: **Blue Sheet Flooring Mastic**
AREA LOCATION: **1951 Orig Bldg Main Entrance**

ASBESTOS DETECTED: **No**

Area Description:	Blue Sheet Flooring Mastic
Area Location:	1951 Orig Bldg Main Entrance
