Re: Asbestos Program
Wiley Elementary School
1602 S. Anderson Street, Urbana, IL 61801

Additional Inspection Report

July 18, 2018

21936

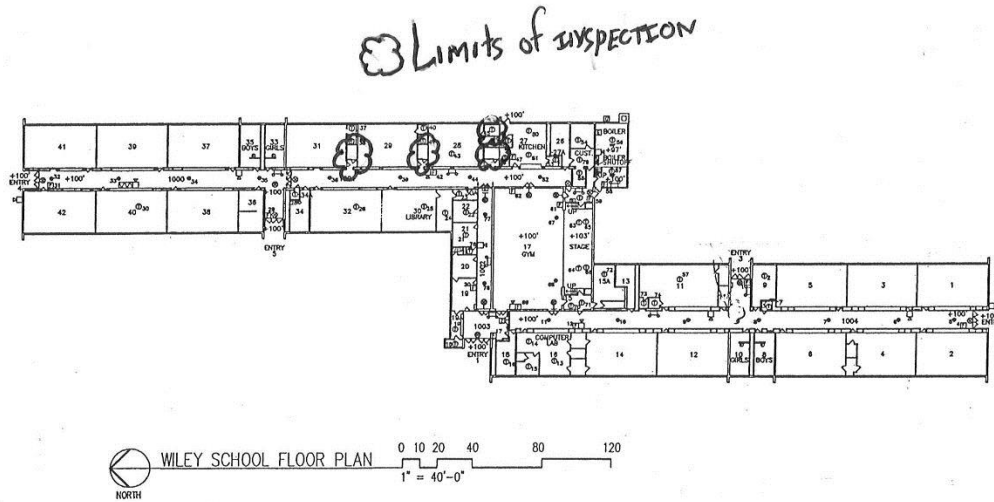
CATEGORY: **Miscellaneous-NON-ACM**
SAMPLE AREA ID: **18MCA** SAMPLE NUMBERS: **18MCA-1,2,3**
AREA NAME: **Ceiling Panels** AREA ESTIMATE: **250 sf**
AREA DESCRIPTION: **2x4 Pin Hole Fissured Ceiling Panels**
AREA LOCATION: **1951 Original Building Rooms 28, 29 & 31 Closets**
